Detail frame of major landslide area

Heavy rainfall on February 20, 2010 caused floods and landslides on the Atlantic island of Madeira. At least 48 people were reported dead and 120 injured. The village of Curral das Freiras in the center of the island was isolated for two days due to blocked or damaged roads. Several mudflows and landslides affected vegetation and infrastructure. Furthermore, many roads on the island were destroyed or blocked.

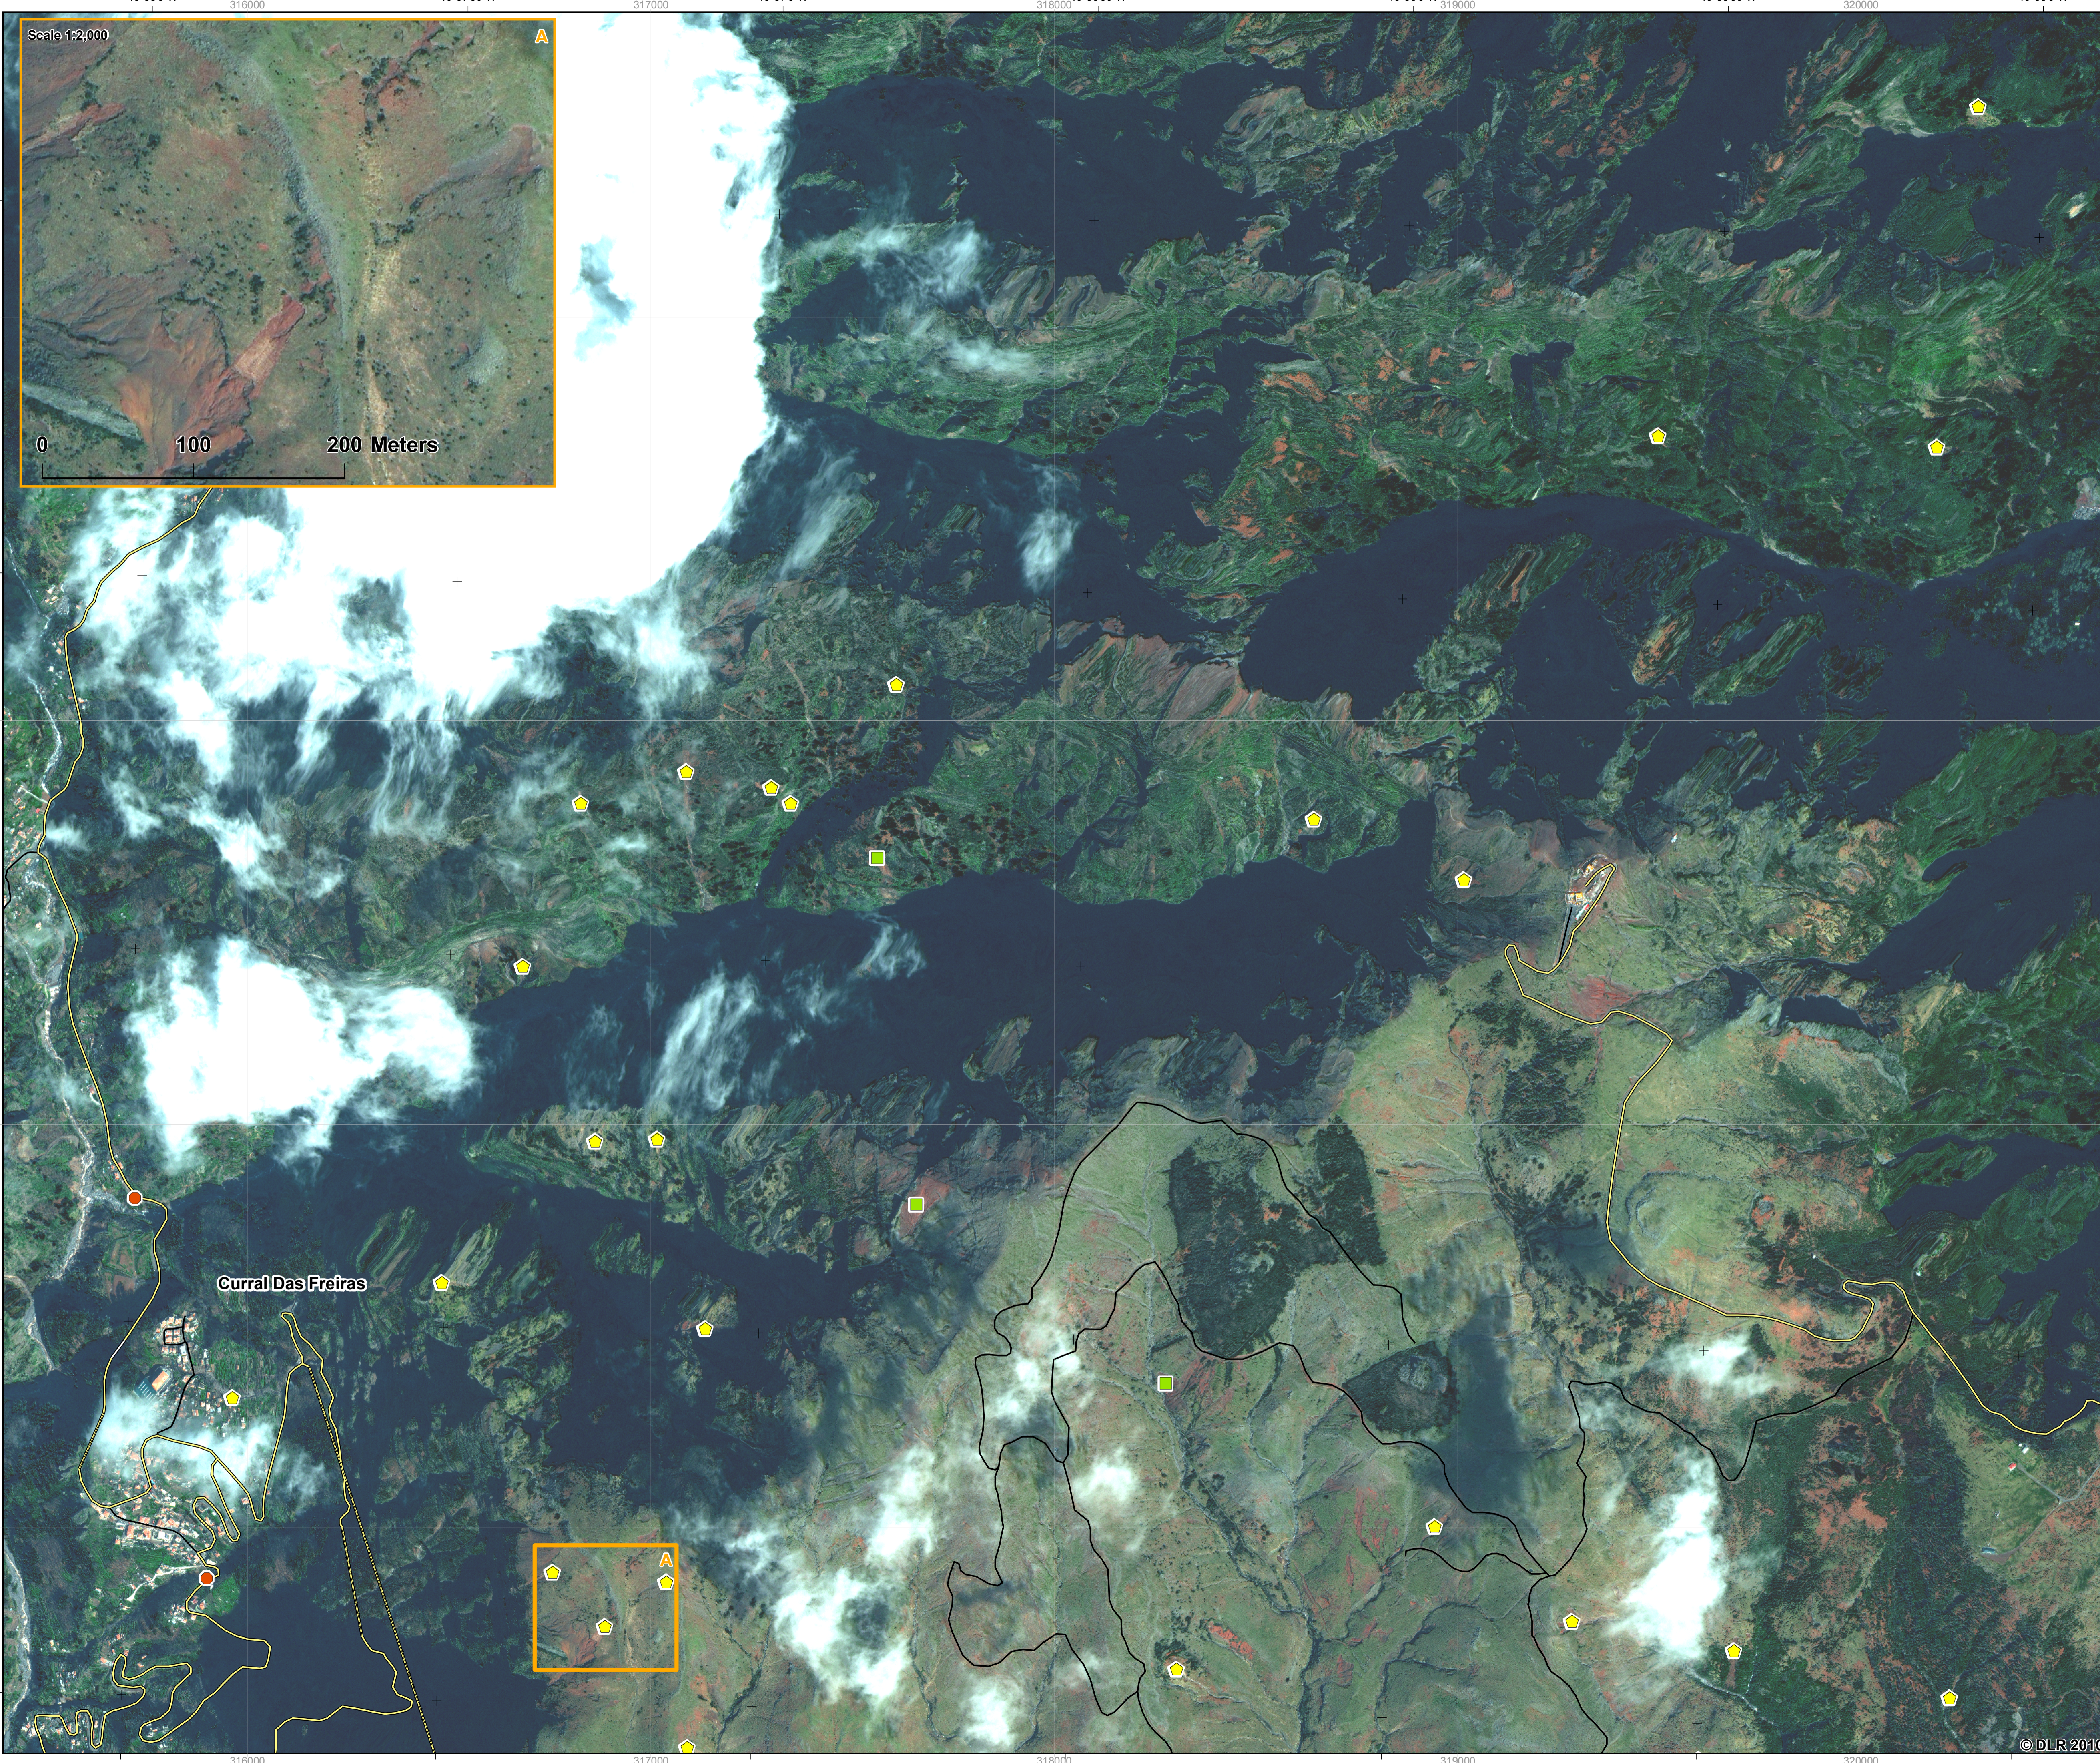
Damage assessment was done through visual interpretation of post-disaster GeoEye-1 imagery acquired on February 23, 2010, and of pre-disaster imagery of the same sensor.
