PORTUGAL - Madeira
Flood - Damage Assessment
Cural Das Freiras - Sheet 3
February 23, 2010
Scale 1:7,500

Interpretation

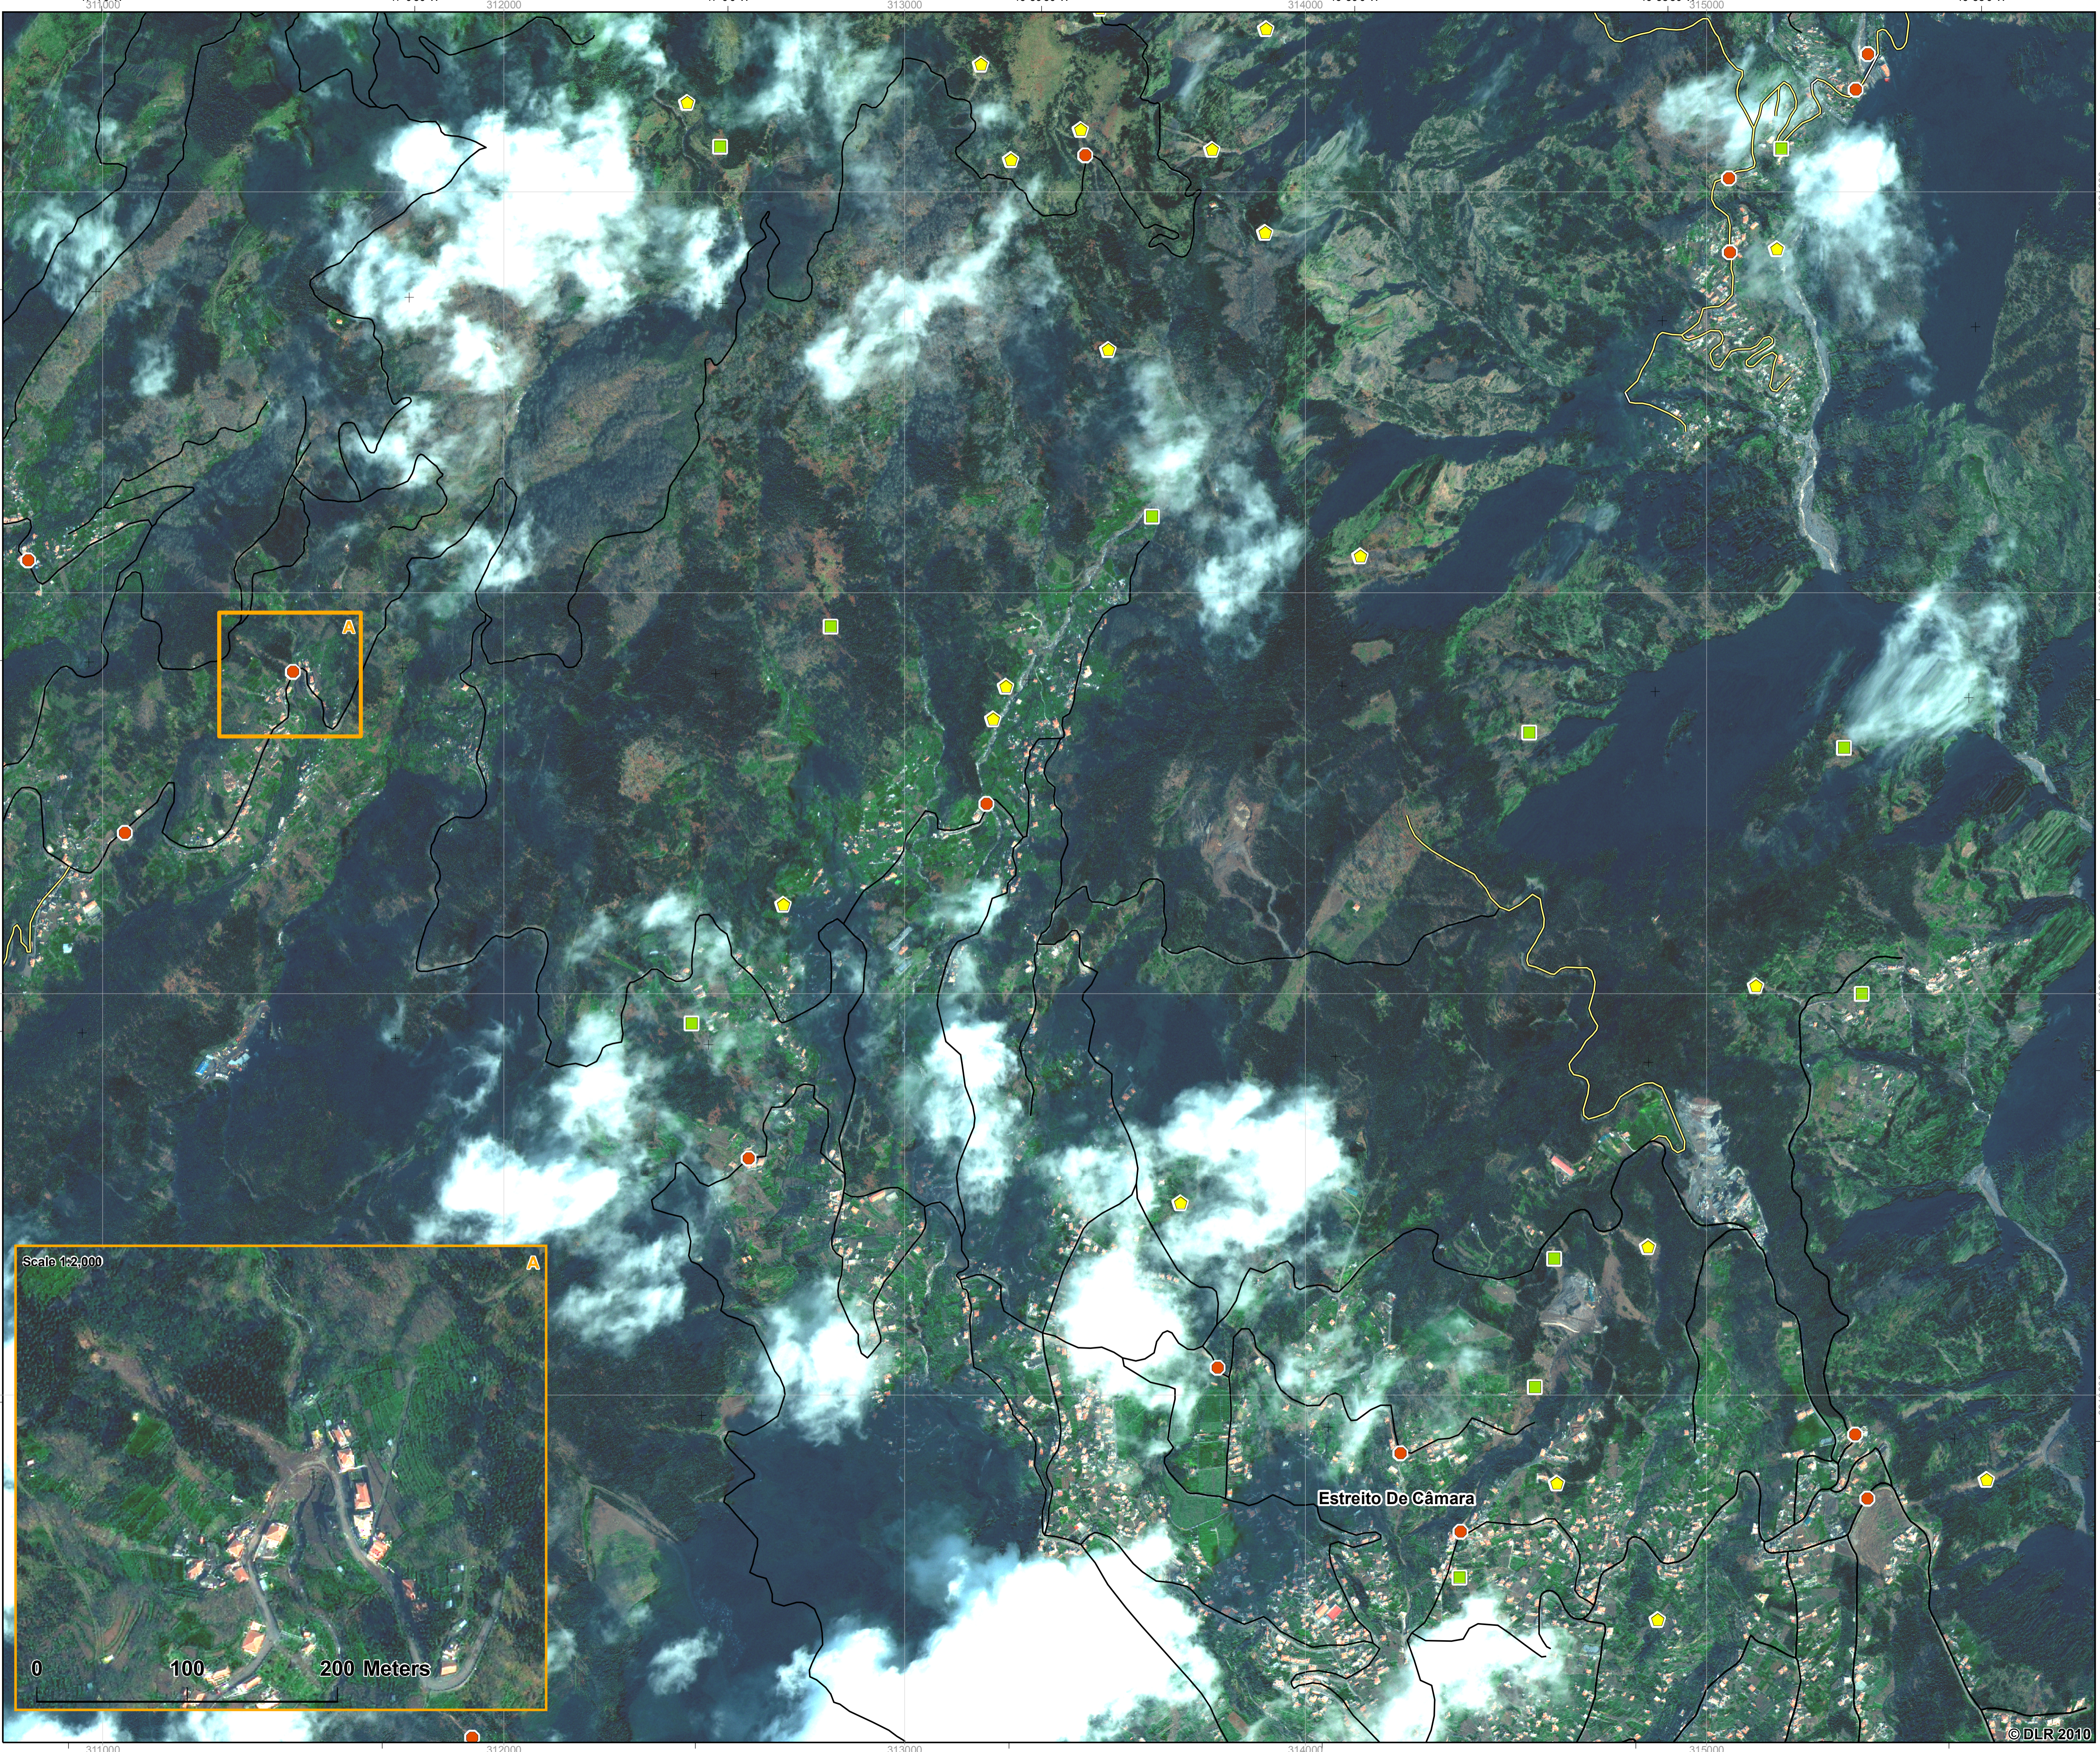
Heavy rainfall on February 20, 2010 caused floods and landslides on the Atlantic island of Madeira. At least 48 people were reported dead and 120 injured. The village of Cural das Freiras in the center of the island was isolated for two days due to blocked or damaged roads. Several mudflows and landslides affected vegetation and infrastructure. Furthermore, many roads on the island were destroyed or blocked.

Damage assessment was done through visual interpretation of post-disaster GeoEye-1 imagery acquired on February 23, 2010, and of pre-disaster imagery of the same sensor.

The analysis may differ from actual damages on the ground.
